**Flood Control Project Maintenance
Levee Inspections**

Fall 2008 Levee Maintenance Deficiency Summary Report

Sacramento River Basin

Reclamation District No. 0003

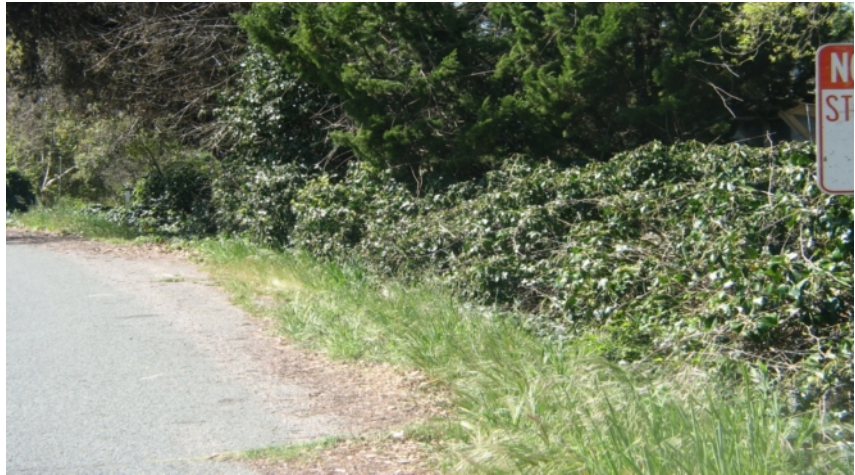
Levee Mile Report Line	5
Start Levee Mile	0.22
End Levee Mile	0.33
Location	
Category	Earthen Levee
Item	Encroachments
Dense landscaping on waterside from LM 0.22 to 0.28

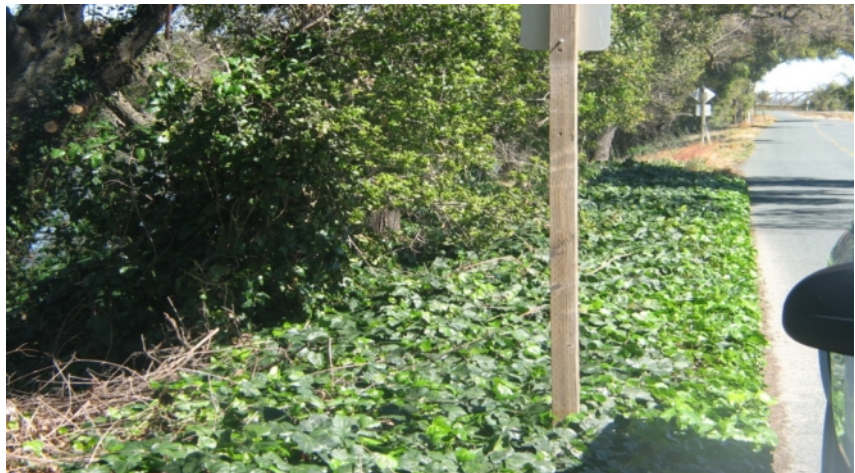
Levee Mile Report Line	5
Start Levee Mile	0.22
End Levee Mile	0.33
Location	
Category	Earthen Levee
Item	Encroachments
Looking upstream at dense landscaping on waterside slope from LM 0.22 to 0.28

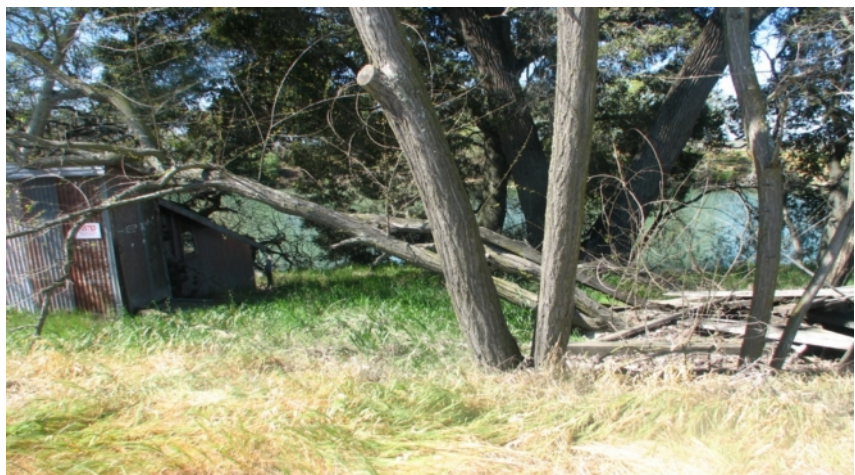
Levee Mile Report Line	8
Start Levee Mile	0.58
End Levee Mile	0.58
Location	
Category	Earthen Levee
Item	Encroachments
Down tree limbs on waterward slop at LM 0.58

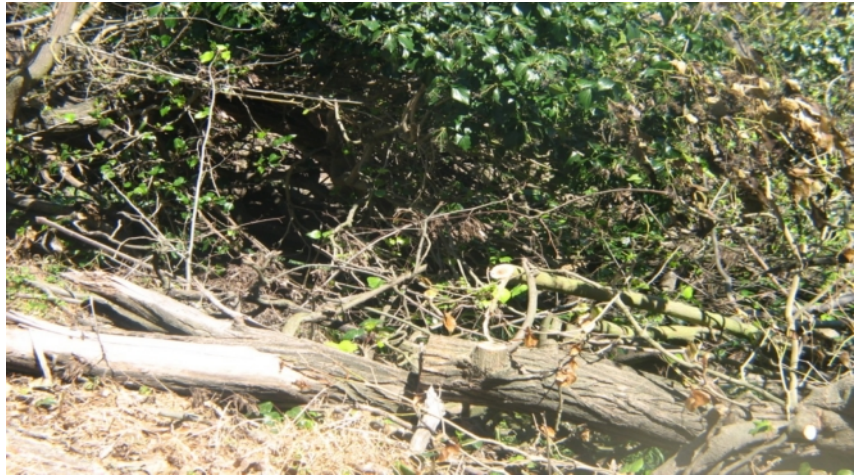
Levee Mile Report Line	15
Start Levee Mile	1.08
End Levee Mile	1.09
Location	
Category	Earthen Levee
Item	Trim / Thin Trees
Down tree limbs on landside slope from LM 1.08 to 1.09

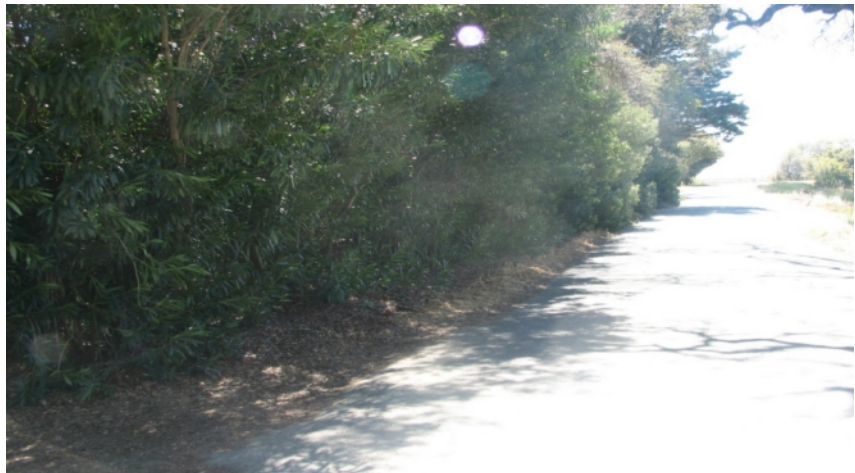
Levee Mile Report Line	17
Start Levee Mile	1.21
End Levee Mile	1.27
Location	
Category	Earthen Levee
Item	Encroachments
Landscaping on landside slope block view of levee from LM 1.21 to 1.27

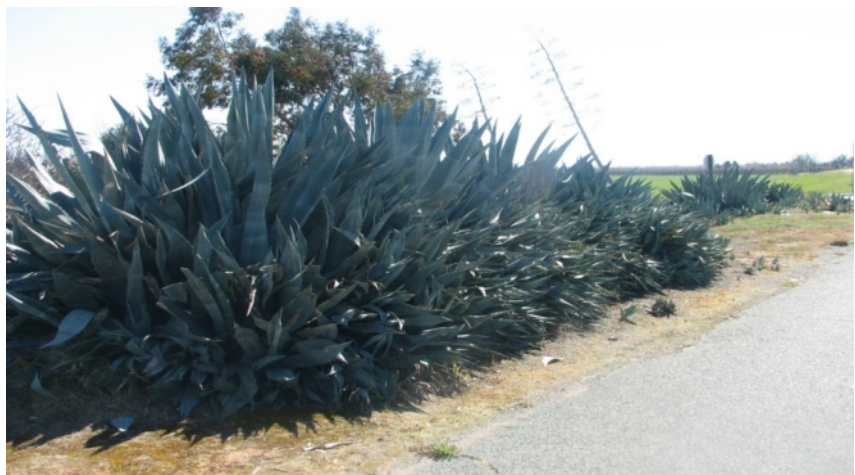
Levee Mile Report Line	47
Start Levee Mile	7.08
End Levee Mile	7.10
Location	
Category	Earthen Levee
Item	Encroachments
Large Cactus plant on landside shoulder block view of levee slope from LM 7.08 to 7.10

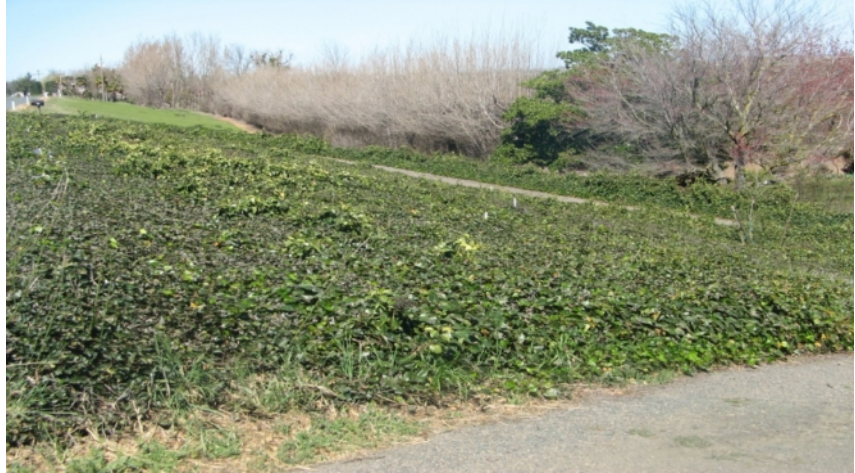
Levee Mile Report Line	50
Start Levee Mile	7.95
End Levee Mile	8.00
Location	
Category	Earthen Levee
Item	Encroachments
Landscaping (Ivy) on landside slope blocking view of levee from LM 7.95 to 8.00

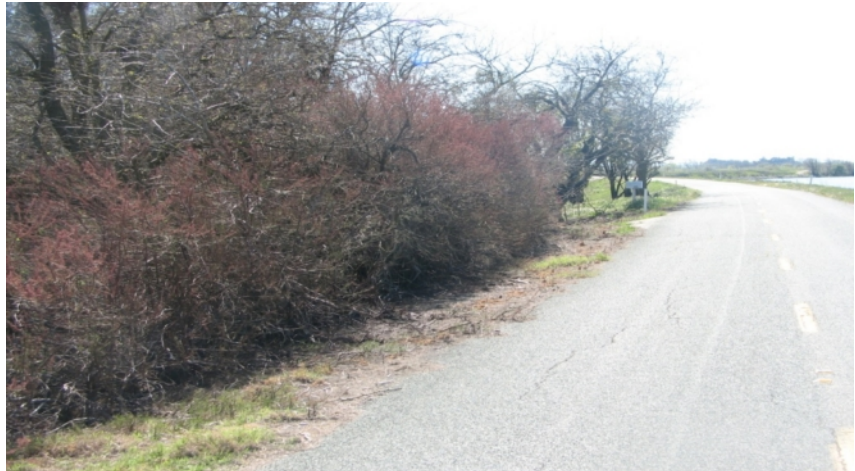
Levee Mile Report Line	55
Start Levee Mile	10.20
End Levee Mile	10.22
Location	
Category	Earthen Levee
Item	Trim / Thin Trees
Tree to be trimmed on landside shoulder from LM 10.20 to 10.22

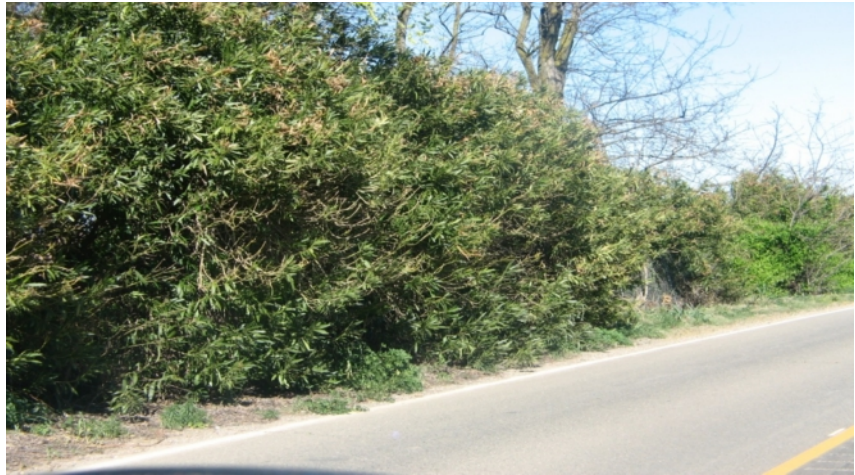
Levee Mile Report Line	23
Start Levee Mile	5.94
End Levee Mile	6.00
Location	
Category	Earthen Levee
Item	Encroachments
Oleander on landside shoulder blocking view of levee slope from LM 5.94 to 6.00

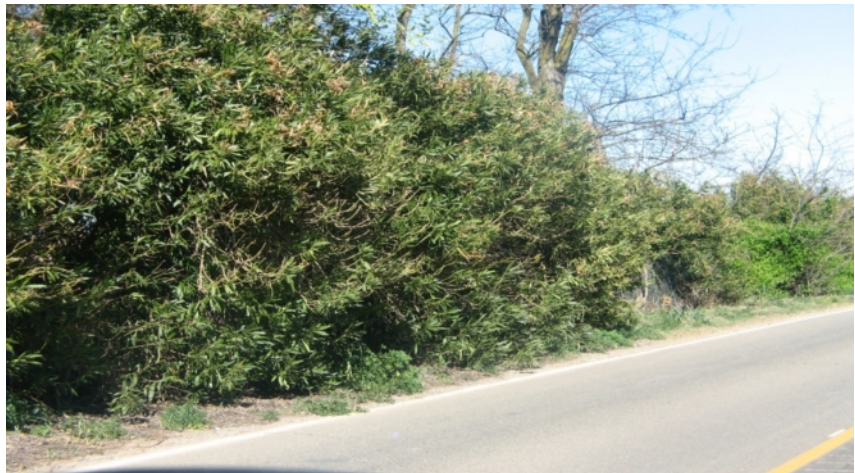
Levee Mile Report Line	23
Start Levee Mile	5.94
End Levee Mile	6.00
Location	
Category	Earthen Levee
Item	Encroachments
Oleander on landside shoulder blocking view of levee slope from LM 5.94 to 6.00

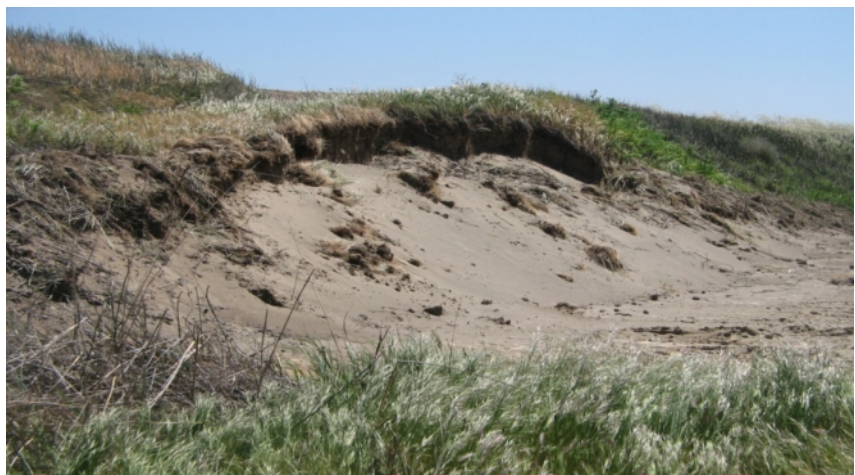
Levee Mile Report Line	28
Start Levee Mile	7.27
End Levee Mile	7.33
Location	
Category	Earthen Levee
Item	Slope Stability
Landowner has removed 300' of material on landward slope next to a ramp at LM 7.27

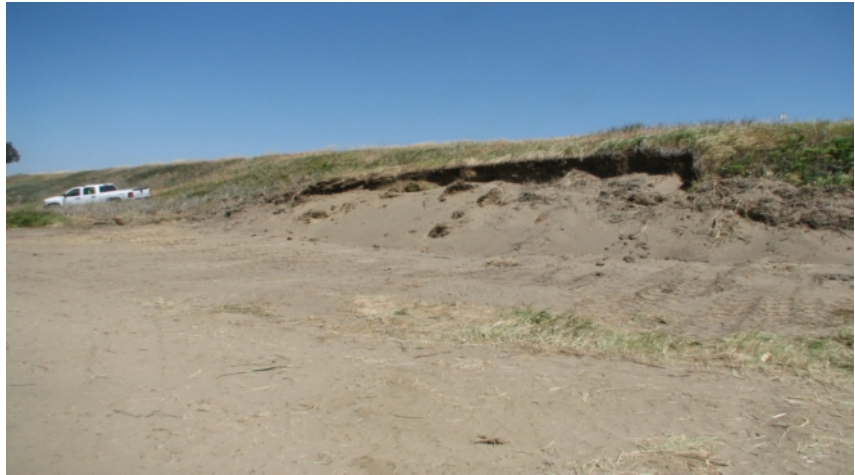
Levee Mile Report Line	28
Start Levee Mile	7.27
End Levee Mile	7.33
Location	
Category	Earthen Levee
Item	Slope Stability
View looking upstream at damage site.

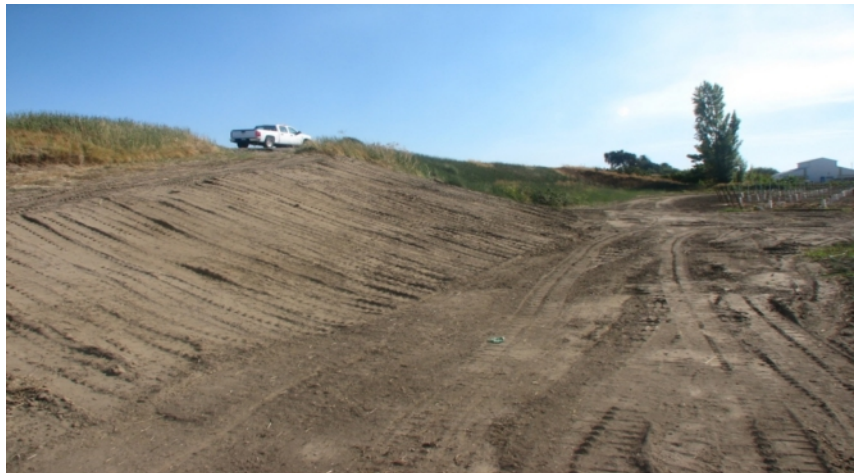
Levee Mile Report Line	28
Start Levee Mile	7.27
End Levee Mile	7.33
Location	
Category	Earthen Levee
Item	Slope Stability
View looking downstream at repaired site. Site was repaired w/out DWR supervision. No cerifited compaction results provided.

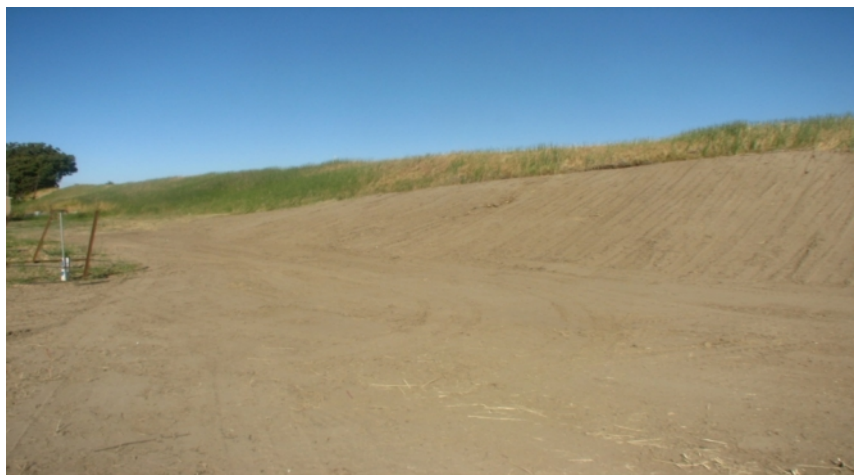
Levee Mile Report Line	28
Start Levee Mile	7.27
End Levee Mile	7.33
Location	
Category	Earthen Levee
Item	Slope Stability
View looking upstream at repaired site.

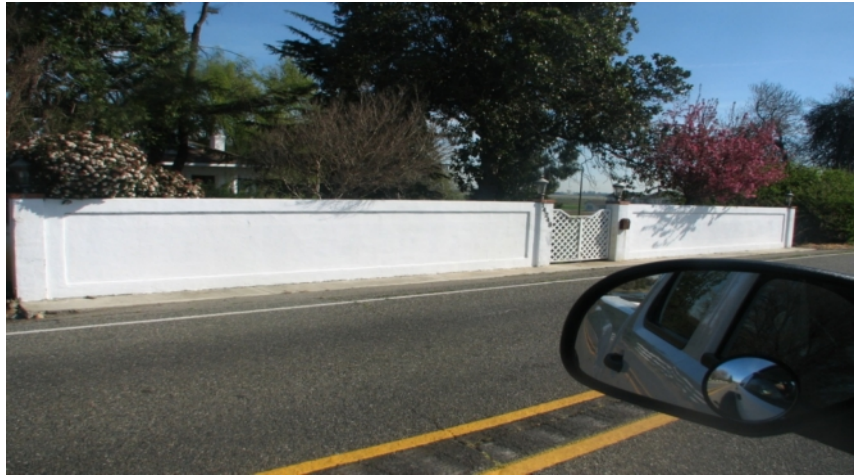
Levee Mile Report Line	36
Start Levee Mile	10.13
End Levee Mile	10.13
Location	
Category	Earthen Levee
Item	Encroachments
Block/Concrete fence on landside shoulder at LM 10.13

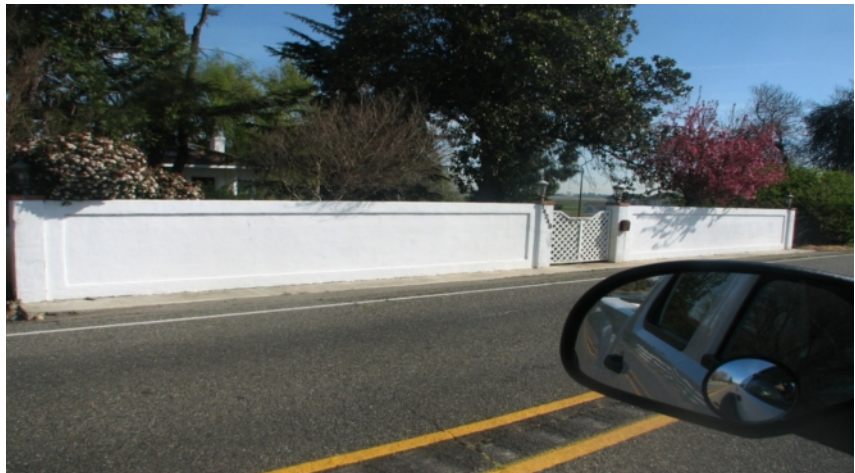
Levee Mile Report Line	36
Start Levee Mile	10.13
End Levee Mile	10.13
Location	
Category	Earthen Levee
Item	Encroachments
Block/Concrete fence on landside shoulder at LM 10.13

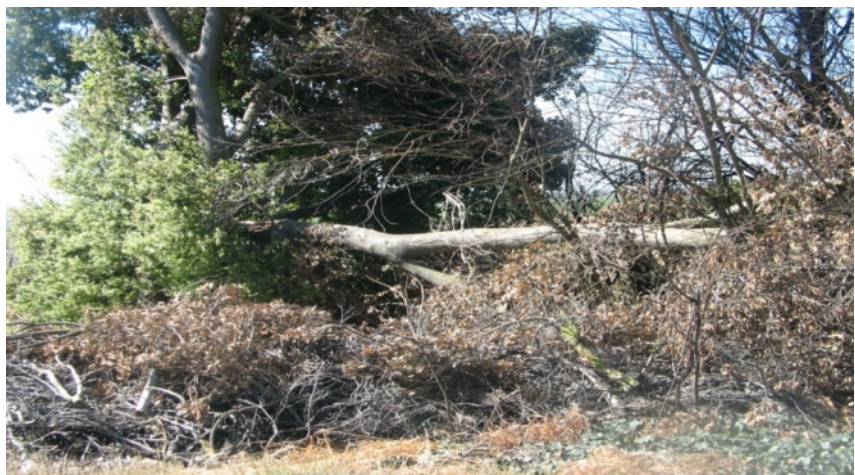
Levee Mile Report Line	81
Start Levee Mile	15.83
End Levee Mile	15.83
Location	
Category	Earthen Levee
Item	Encroachments
Down tree limbs on landside slope at LM 15.83

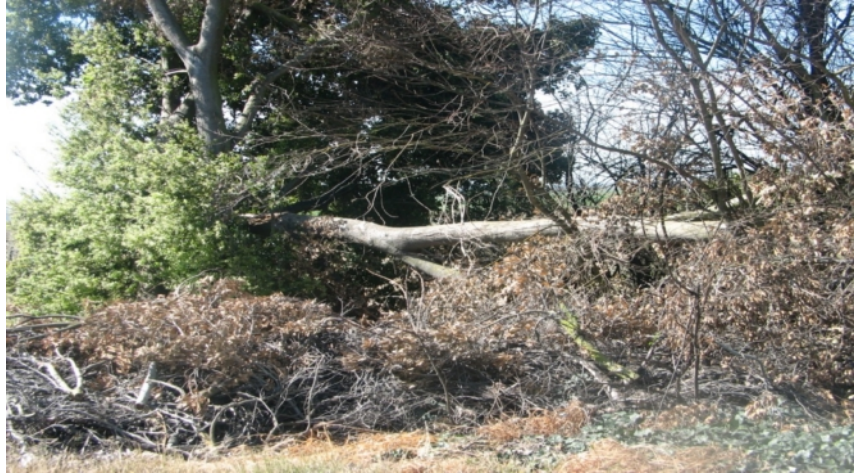
Levee Mile Report Line	81
Start Levee Mile	15.83
End Levee Mile	15.83
Location	
Category	Earthen Levee
Item	Encroachments
Down tree limbs on landside slope at LM 15.83
